20. A NOTE ON VERY HEAVY FOULING OF COPPER SHEATHED HULLS OF NAVAL CRAFT AT BOMBAY

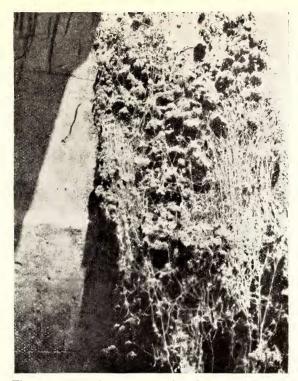
Fig. 1. Fouling of copper sheathing above the bilge-keel. (Portion on the left has been scraped, exposing copper plates.)
